# **SOURCE CONTROL EVALUATION REPORT**

## **MCCALL OIL AND CHEMICAL SITE**

McCall Oil and Chemical Corporation  
Portland, Oregon

**February 2009**

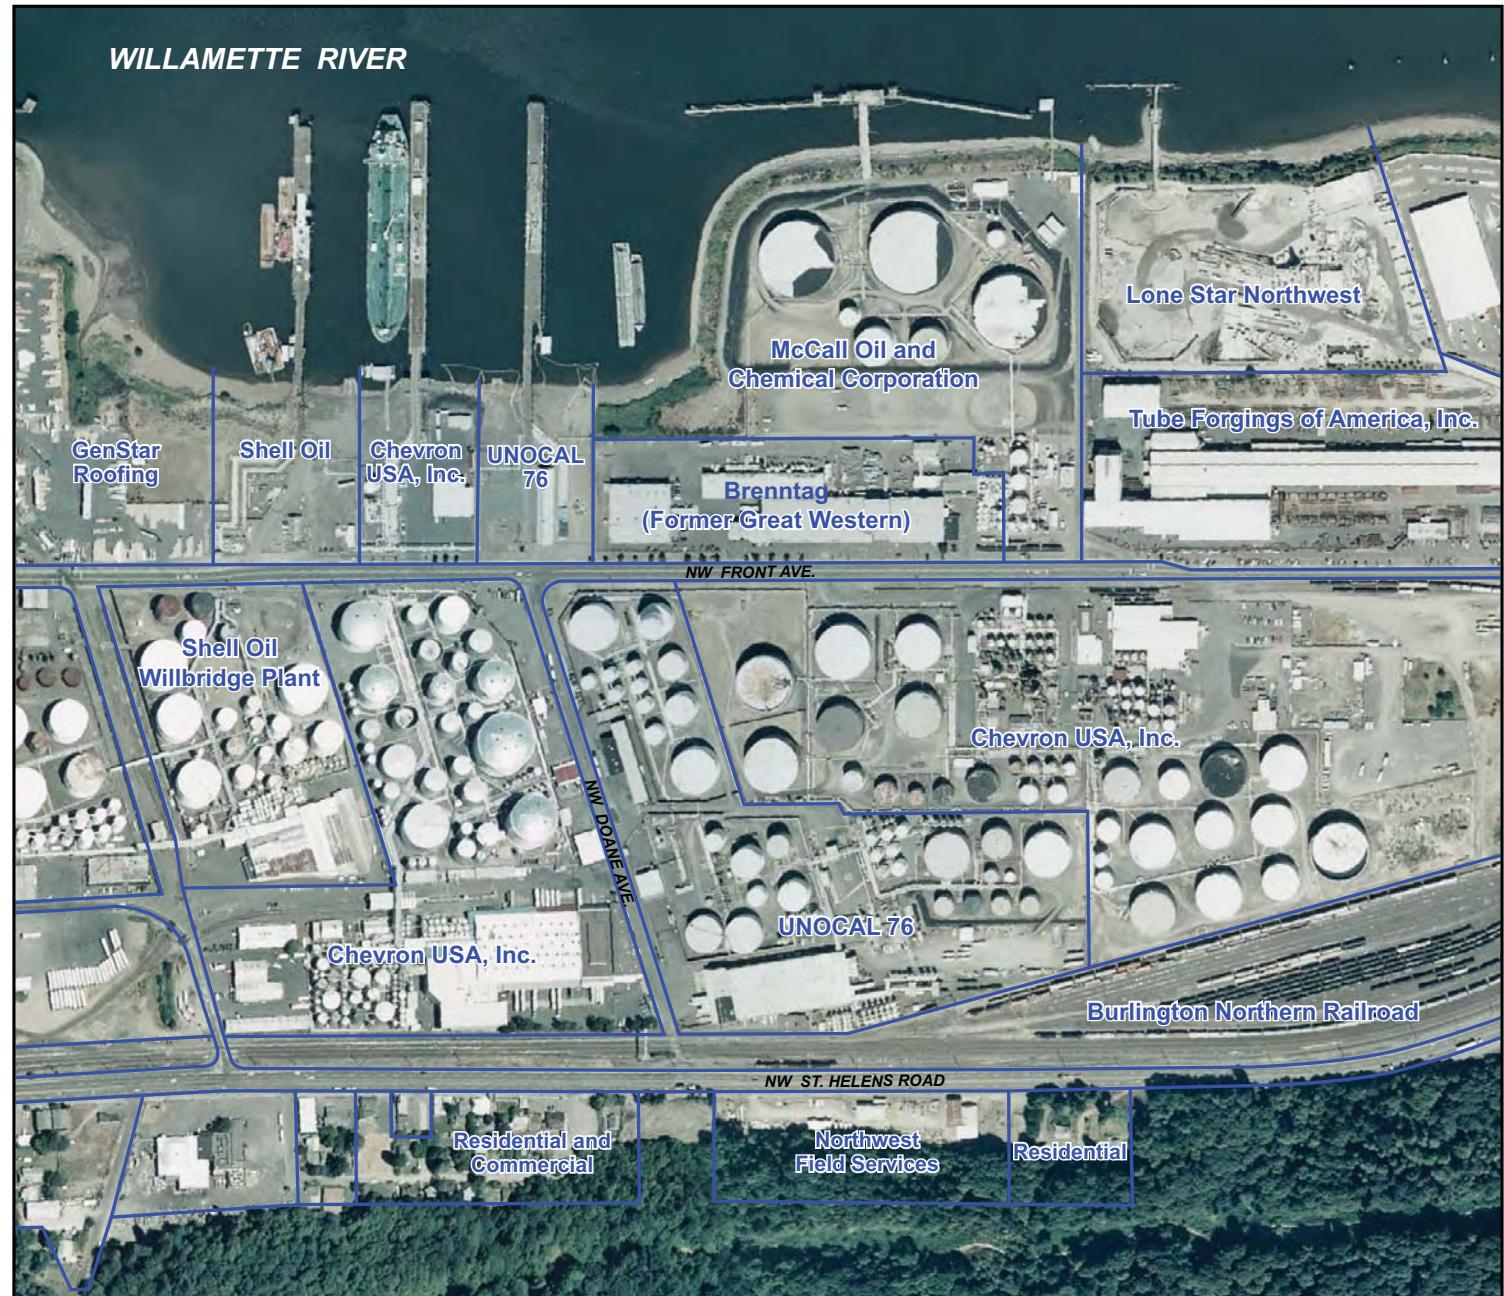
**Figure 2**  
Land Use Map  
McCall Oil  
Portland, Oregon

Before 1966, most of the land now occupied by the MOCC Oil Terminal was submerged beneath the Willamette River (Figure 2). The Port of Portland (Port) created new land along the Willamette during the mid-1960s by dredging and filling along the shore. This land, including a portion of the Site, was deeded to the Port by the State of Oregon in 1967. A detailed description of the ownership and operational history of the Site is in the *McCall Oil and Chemical Corporation Focused Remedial Investigation Workplan* (Workplan) (IT Corporation 2000), and in the Remedial Investigation (RI) Proposal, which is Appendix D to the Workplan.
